STUDY OF CONSERVATIVE CONDITIONS OF “EL PATIO DE ESCUELA MENORES” (SALAMANCA, SPAIN)

The following petrographic study deals with the lithological identification of rocks, the recognition of the pathology and the evaluation of conservative state of the material used in “*El patio de escuela menores*”, one of the most famous building placed in the “Old City” of Salamanca (Spain) (Fig.1).

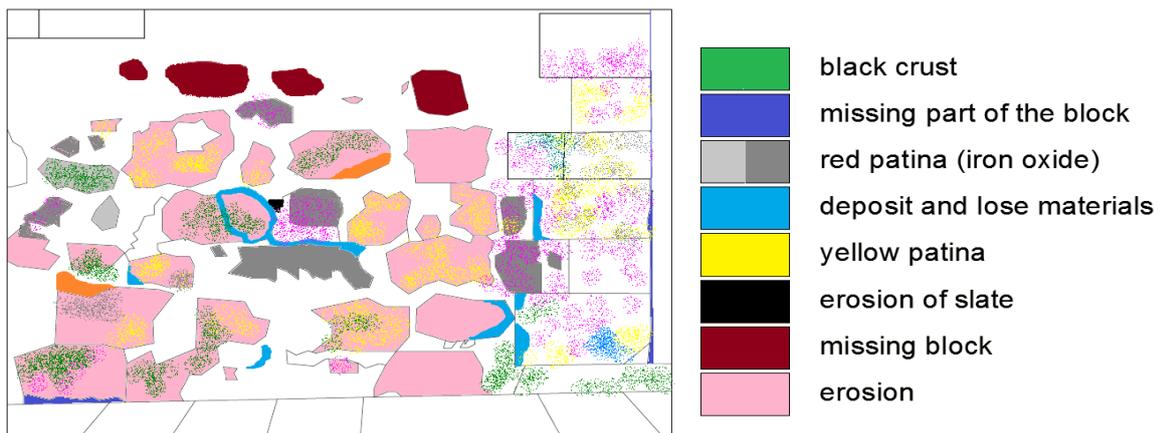
These constructive blocks show different conservative condition and degradation phenomena: lacks, superficial erosion, shaped angle, etc. and other decay due to environmental exposure and to kind of materials (Fig. 4-6).

Fig. 4. Types of decays in the external Wall in Calle Plata.

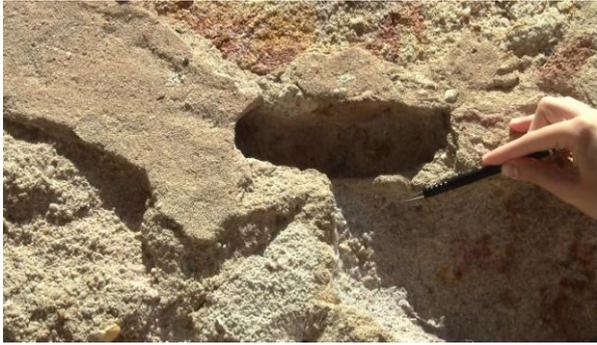
Fig. 5. Coving (disaggregation of individual geologically weaker sandstone blocks due to the consequential effect of repointing the joints and beds with a too hard and durable cementus mortar), lack, superficial erosion.

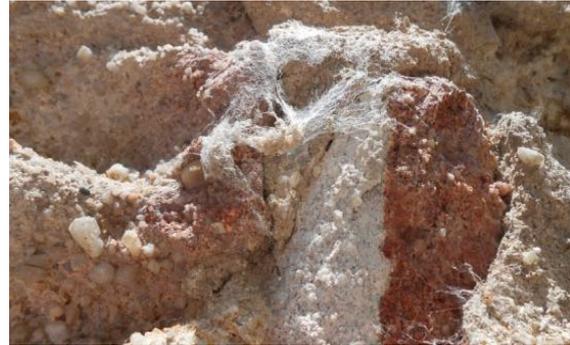
Fig. 6. Superficial erosion, iron oxide decay (red), biological attack (spider web), lack.

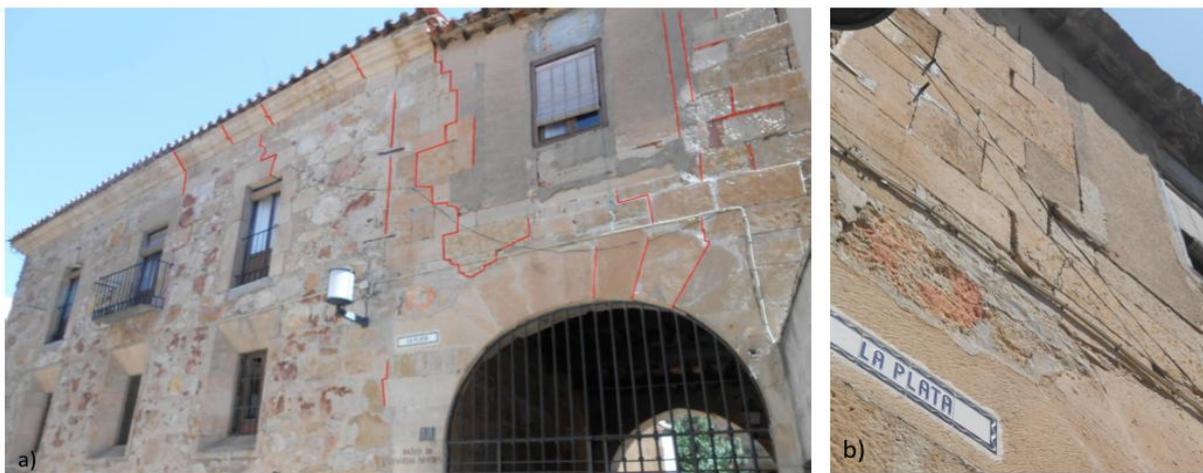
Therefore, the use of rocks and materials with different physical-chemical-mechanical properties can cause stability problems to the architectonic structure with structural failures, such as those occurred following Lisbon Earthquake in November, 1st 1755. Indeed, one of the principle problems observed in “Patio de Escuelas Menores” are in the blocks that constitute the entrance arc and the external wall (Fig. 7).

Fig. 7. External wall: a) fissure's map on probably due to seismic event (red line); b) fissure and blocks' displacement.

Seismic activity, over the years, has created fractures on the wall and it opened spaces between the blocks and these ones have started to collapse. Furthermore, the consequently weight increase started to damage also the wooden inner structure (Fig. 8). However it's not possible to say that these ones have only direct correlation with the seismic activity, and it would be necessary to monitor them for a long period of time to give a more conclusive answer.

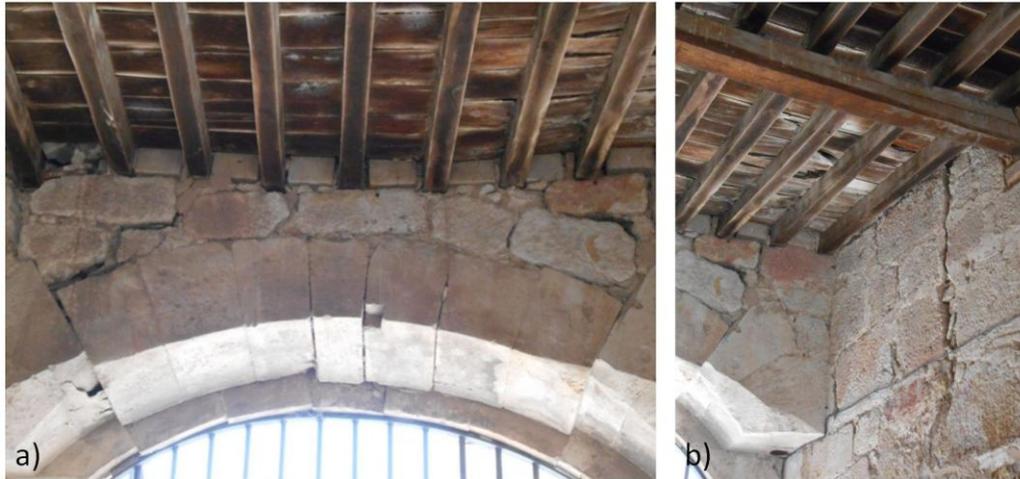
Fig. 8. The upper part of the entrance arc, where the blocks of Villamayor Sandstone have started to collapse (a) fissures in the wooden structure and fracture on the left internal wall (b).

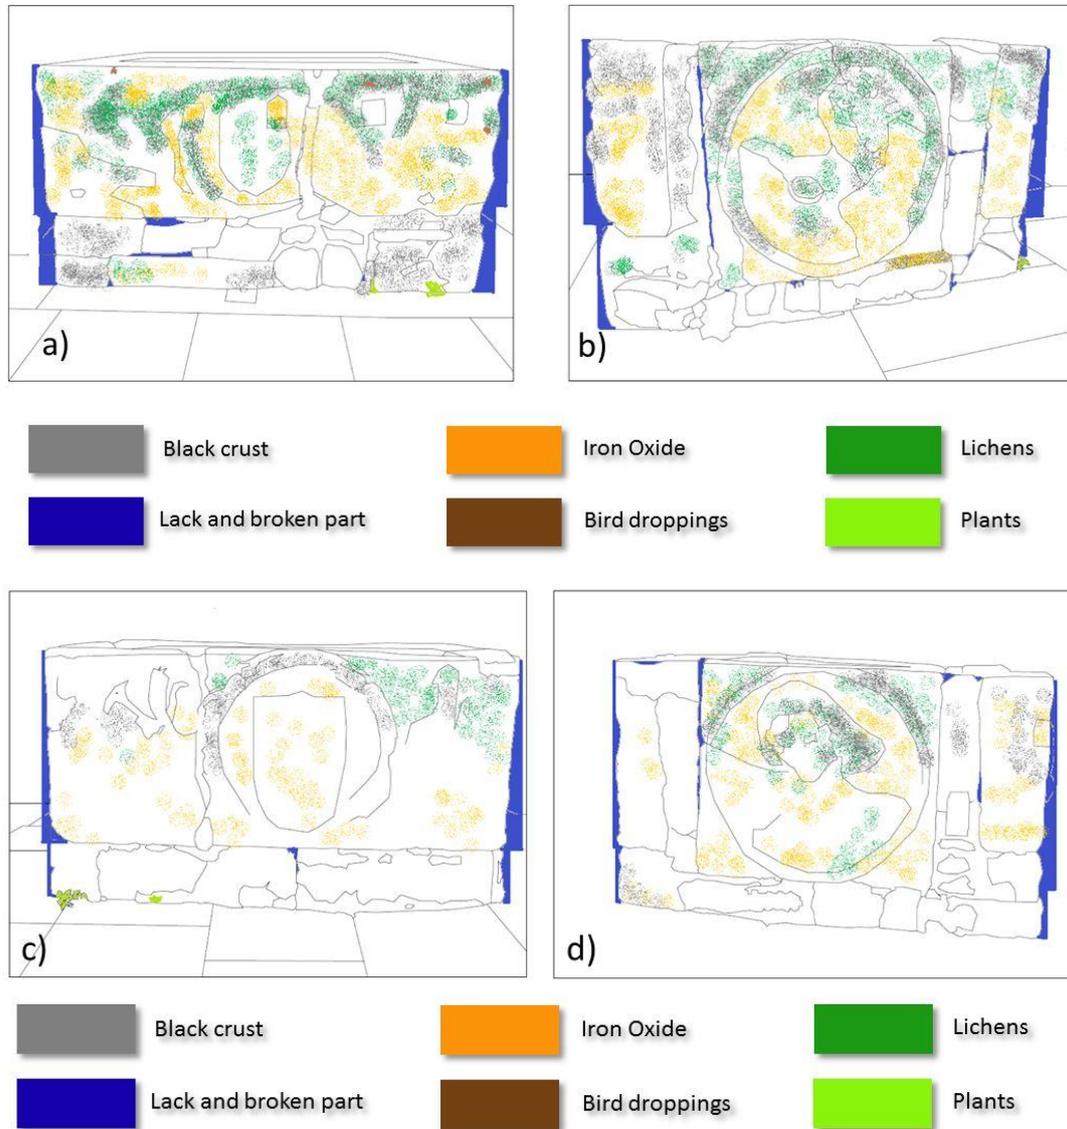
The fountain shows lots of problems probably due to weathering, being exposed to environmental agents. It is possible to see erosion phenomena in all the four part of the monument and other localized area with different decay that could be dangerous for sculpture, etc. (Fig. 11-15).

Fig. 11. Conservative condition's maps of fountain: a) N-E side; b) N-W side; c) S-W side; S-E side.

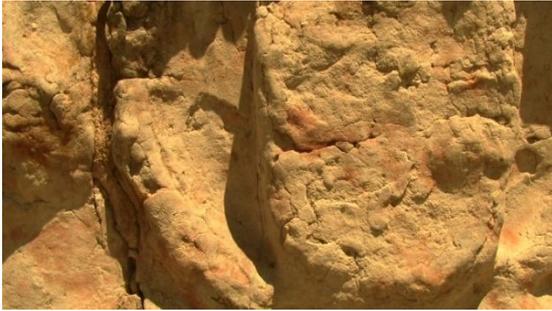
Fig. 12. Superficial erosion of bas-relief that caused loss of carved details, and smoothed shapes [2].

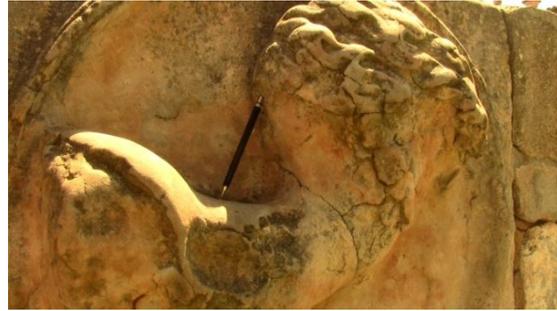
Fig. 13. Black crust, iron oxide patina (red patina), superficial erosion, lack material [2].

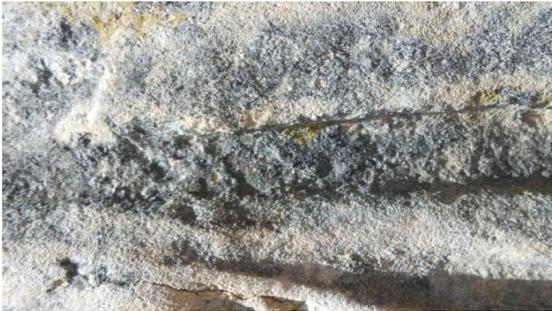
Fig. 14. Superficial erosion, black crust and lichen [2].

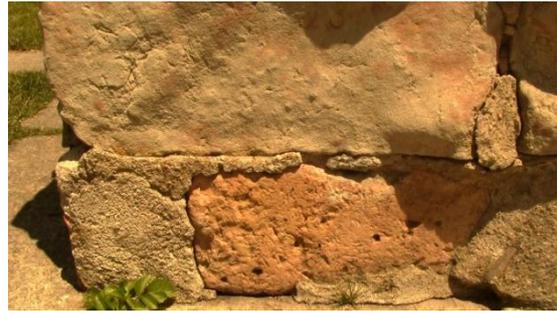
Fig. 15. Superficial erosion, iron oxide patina (red patina), human activities' decay (hole, scratched line, ecc.) on brick probably linked to re-used material, biological attack (lichens and plants) [2].

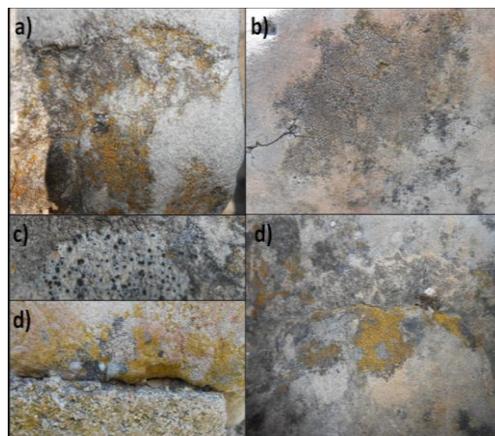
Biodeteriogenic microorganisms, such as lichen, were found especially in the upper part of the bas reliefs and on the higher part of fountains' block. It is possible to recognize four different kinds of lichens: orange, yellow, white and black crusty thallus lichen (Fig. 16).

Fig. 16. Different kinds of lichens.
