COMPARATIVE ANALYSIS FOR THE ASSESSMENT OF RESTORATION TREATMENTS ON STONE MATERIAL FROM THE ROMAN THEATER OF MERIDA (SPAIN)

The work described arises from the collaboration between different research groups, under the framework of the PICATA programme (CEI Campus Moncloa):

The overall goal of the project is the study of effects of conservation treatments applied on stone material from archaeological sites, in terms of superficial changes, effectiveness and durability. In this sense, one of the first premises is characterize the surface of the treated and untreated material in order to determine changes in physical and chemical properties.

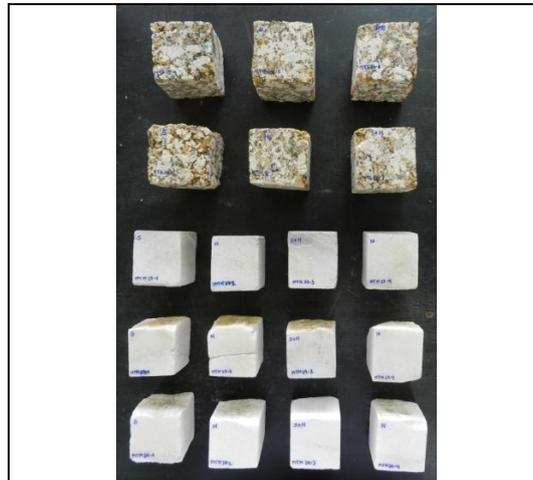
Fig.2: Marble and granite samples: (S) samples treated with Ethyl Silicate, (H) samples with a hydrophobic product, (S+H) samples with both treatments, and (N) non-treated samples.

and granite from the Front Stage of the Roman Theatre (Figure 2), material present in many other remains of the city, due to the proximity of the quarries [1].

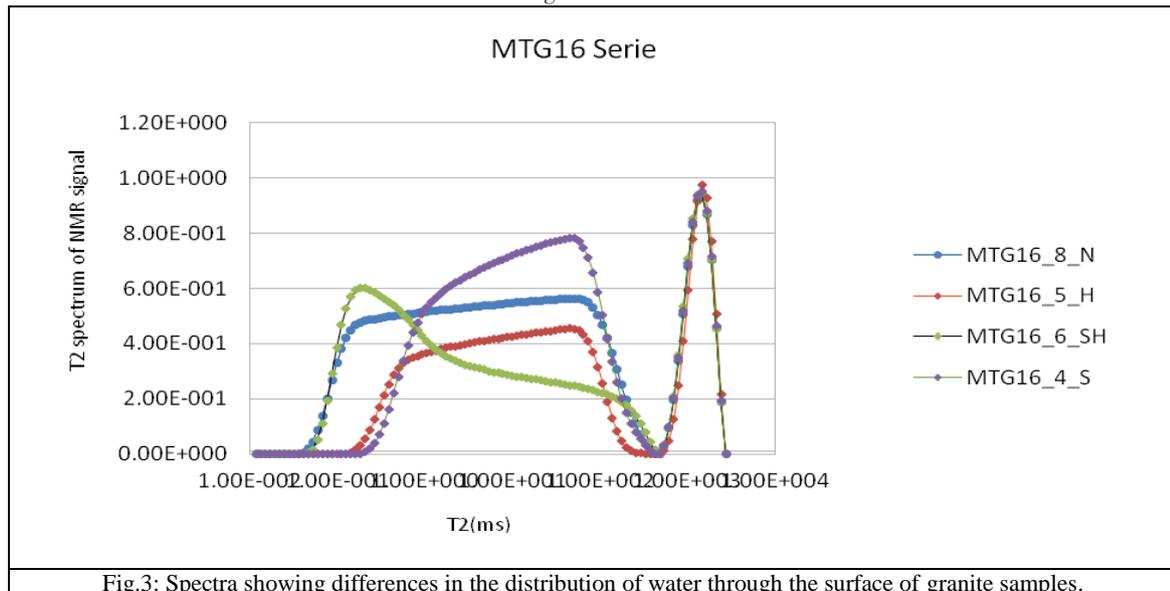
A general review of NMR spectra shows exceptional changes in the distribution of water in the pore system by the effect of the different treatments (Figure 3). In contrast, Porosimetry Hg tests show an overall decline of the porosity (from a 3.84% in untreated samples to a 0.21% in treated with S+H in MTM27 samples) as well as a shift in the balance between micro and macro-porosity, favouring the first one in the case of granites.

Finally, NMR measurements, although showing more heterogeneous outcomes, allow observing some changes in the balance between micro-, mid- and macro-porosity. It also shows a tendency to homogenize the distribution of water in the pore system in samples treated with a hydrophobic product, thus, the water gets all kinds of pores, while in the untreated sample it is mainly located in micro-pores.
