ANALYSIS OF THE STATE OF CONSERVATION OF FUNERAL MURAL PAINTING DEDICATED TO IGNATIUS MAGNANI (CIMITERY “LA CERTOSA”, BOLOGNA, ITALY)

This paper shows the study, conducted on one of the oldest funeral monuments in the Certosa: the artwork dedicated to Ignatius Magnani (1740-1809), distinguished lawyer and professor of Bologna University (Fig.1).

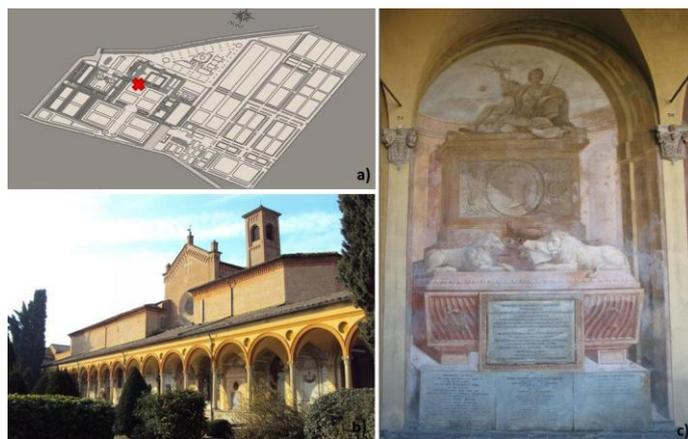
Fig. 1. Monumental Cemetery Cemetery “La Certosa” (Bologna, Italy): a) the cross shows the position of Ignatius Magnani monument, in court yard III; b) courtyard III; c) Ignatius Magnani monument.

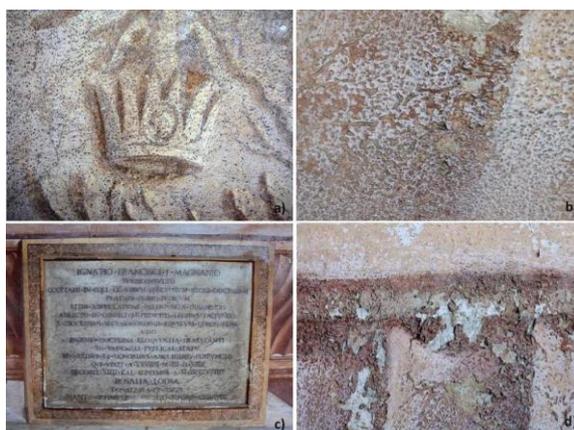
Fig. 2. Degradation phenomena on the funerary monument: a) surface with black spots; b) film-white paint; c) tombstone; d) deficiencies, lifting the film.

Moreover, past restoration works, carried out in 19th and 20th century, caused further deterioration phenomena (white and glossy films, pictorial losses, etc.), probably linked to the inadequacy of the used products. The presence of black μ spots, located on different portions of the pictorial film (Fig. 2a), suggests a biological attack under the covering dust deposits.

Black crusts, yellowing and loss of material were found, finally, both on tombstone dedicated to Ignatius Magnani (Fig. 2 c) and on the gravestones of his heirs, where loss of pigments in the inscriptions and discoloration could be caused by old waxes applied on the surface (Fig. 2 c).

Finally, considering the delicacy of the this monument, its terms and conditions, it will be opportune a future reversible restoration, which objectives are both the re-establishment of cohesion-adhesion of the pictorial film and the full refund painted image readability.

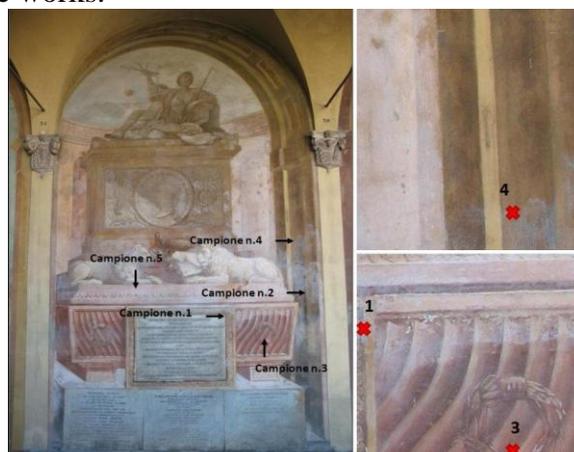
Considering this aspects, an analytical survey, carried out on samples of microscopic size (Fig.3), taken from the artifact, can allow the correct interpretation of the opera and of the environment in which it is inserted. Research on samples were aimed at the identification of artistic technique, materials (pigments film pictorial, intonachino, protective, etc.) and the evaluation of chemical-physical and biological degradation. Optical (OM) and electronic microscopy (SEM) with chemical microanalysis (SEM-EDS), providing useful support for the design of future conservative restoration and maintenance works.

Fig. 3. Sampling points' map.

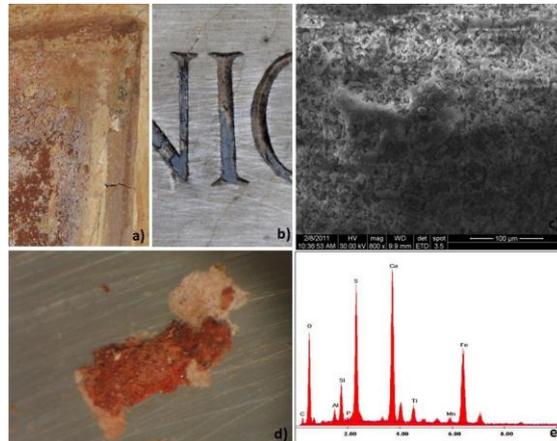
Results of investigations confirms the hypothesis about artistic techniques (mural painting with organic medium and not fresco) and transposition of the sketch on the decorative surface. To obtain different colors, the artists used common pigments (ochres, etc.) (Fig. 4); meanwhile, during the subsequent restoration, titanium dioxide was used, probably as an additional protective. The application of a protective film made by synthetic type resins (i.e. polyvinyl resin) could cause lifters and posting of pictorial material (Fig. 2b, 2d).

Fig.4. Pictorial film: a) brune-red area;b) black pigment in inscription; c) SEM image, d) OM image, e) SEM/EDS of sample n. 3 (red ochre).

Therefore, to determine the nature of the organic material, it would be useful to deep the search through more in-depth investigation (GC-MS, etc.) in order to identify the most compatible products for cleanup operations, not damaging pictorial film.

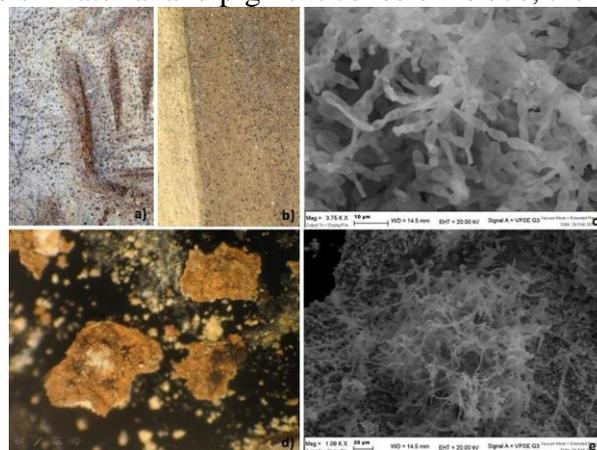
Furthermore, morphological study, carried out at SEM, confirms the presence of biotic attack (Fig. 5), showing, in fact, an abundant growth of fungal mycelium on the film surface and in material's porosity (Fig. 5c, 5e). The growth of fungal species also interested the ink of the letter I and the marble tombstone: the loss of material and pigment cohesion is due, then, to biodegradation.

Fig. 5. Fungal colony on pictorial surface: a) b) macro-photography, c) e) SEM image, d) OM image.

Even if SEM investigation allowed to study the morphology of organisms involved in the degradation of artistic artifact (Fig. 5), suggesting the presence of *Baudoinia compniacensis* (Richon) and fungi *Aureobasidium*, it would be appropriate to proceed by culture and subsequent analysis of molecular biology for a sure identification in order to find more focused and effective action of cleaning and maintenance [3].
