## **CORBIGNANO (FLORENCE): MAINTENANCE OF THE ORIGINAL RENDERS TO PRESERVE THE AUTHENTICITY OF THE SITE**

**E. Pecchioni<sup>1</sup>, F. Fratini<sup>2</sup>, L. Serra<sup>3</sup>**

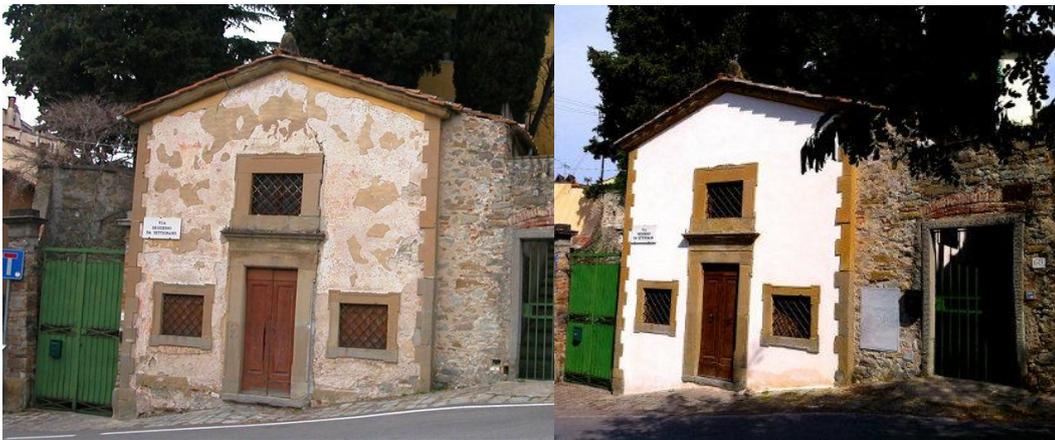
Fig. 2. The oratory of the Madonna del Carro, before and after restoration of 2010.

In the case of the Oratory the ancient mortars of the façade were all demolished and the restoration has created a new stratigraphy. The restoration has been realized according to the UNI EN 459-1:2010 [1], and UNI EN 998-1:2010 [2] rules about building's limes and mortars. On the ancient plaster of the church, three layers were laid out: 1- a "rinzafo" made of an hydraulic lime NHL 5 mixed with selected carbonatic and silicatic sand and *pozzolana*; 2- a second plaster made of an hydraulic lime NHL 5 mixed with selected carbonatic and silicatic sand; 3- an external plaster finishing made of lime putty, aged for long time, mixed with inorganic pigments. The extrados of the vault of the church was also subjected to the restoration of structural stability with the addition of carbon fibers in three bands. The carbon fibers are also adopted for the fissures in the intrados in areas not affected by the fresco.
