## **CAPPADOCIAN RUPESTRIAN CHURCHES AND CONSERVATIVE STRATEGIES: FROM THE LAB TO THE ARCHEOLOGICAL SITE**

The goal of this paper is to test some consolidating products, compatible with the rocks composition, and to evaluate their effectiveness [3].

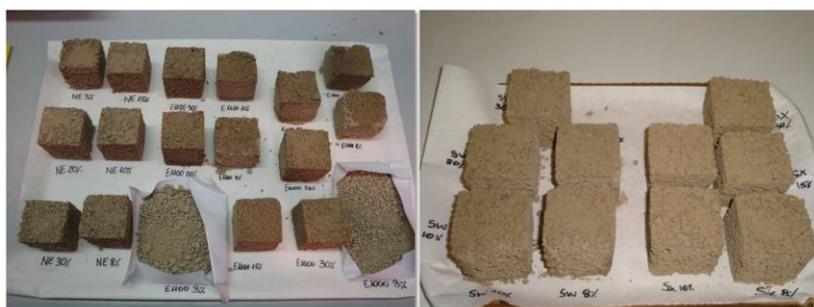
Fig. 2. Consolidated specimens

Moreover, products and ignimbrites fragments were mixed to evaluate their re-aggregating capability and suitability for stucco. The consolidated specimens (Fig. 2) were subjected to peeling test, point load test and shear strength test.

Peeling tests and geotechnical tests carried out on consolidated specimens indicate that NanoEstel Syton W30 e Syton X30 have the best consolidating properties, whereas Estel 1000 and Estel 1100 show an acceptable efficiency just at high concentration.

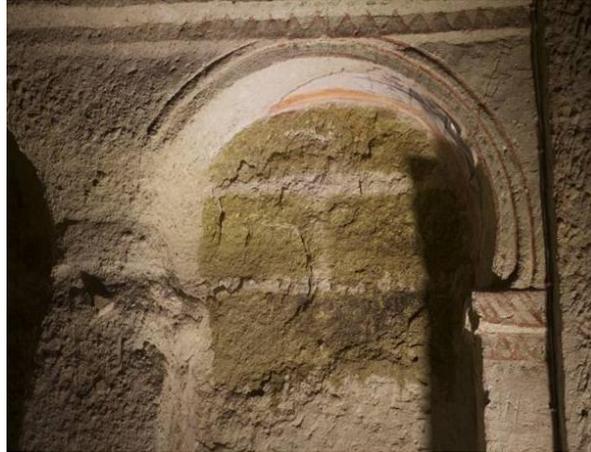
Fig. 3. Treatments in the Tokali church.

On the basis of the laboratory experiments, NanoEstel, Syton W30 and Estel 1000 were chosen to be tested directly on the rupestrian churches' rocks (Fig. 3).

In the Cappadocia sites the treatments were carried out during summer in 2012 and 2013 in the same climatic conditions. Nevertheless the lab results point out the 20 and 30 wt% as best performer, the first applications in site showed the scarce penetration of these treatments that produced a superficial and visible coating; therefore 3 and 6 wt% concentrations were selected. Besides water and white spirit solvents were applied on the surface before the treatments, to increase the product penetration in the substrate. The colorimetric measurements and peeling test (Fig. 4) suggest the good performance of the products especially of NanoEstel and Syton W30 thanks to best and faster penetration than Estel 1000. Besides the solar exposure and high temperatures favored the absorption of treatments in the rock.

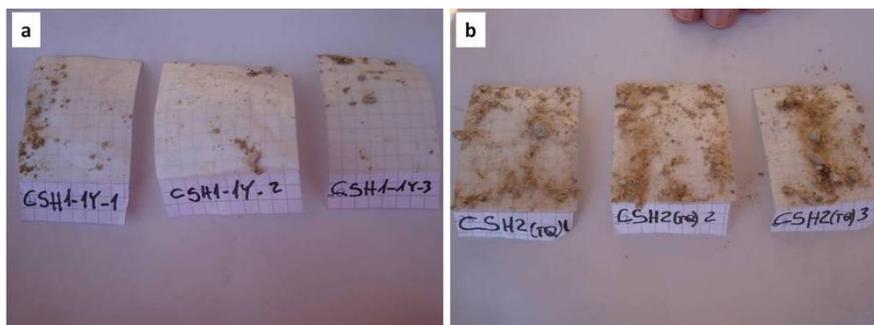
Fig. 4. Peeling test on consolidated (a) and unconsolidated (b) areas on Forty Martyrs outside wall.

After laboratory tests, some treatments have been selected and applied *in situ* nearby the Tokalı and Forty Martyrs churches. The products have been applied both as consolidant and stucco. Their behaviour have been assessed by means of colorimetric and peeling test. The application was carried out inside and outside the churches, choosing areas on the basis of their surface degradation, exposition to atmospheric agents and solar exposure.
