STUDY OF CONSERVATIVE CONDITIONS OF “EL PATIO DE ESCUELA MENORES” (SALAMANCA, SPAIN)

The following petrographic study deals with the lithological identification of rocks, the recognition of the pathology and the evaluation of conservative state of the material used in “*El patio de escuela menores*”, one of the most famous building placed in the “Old City” of Salamanca (Spain) (Fig.1).

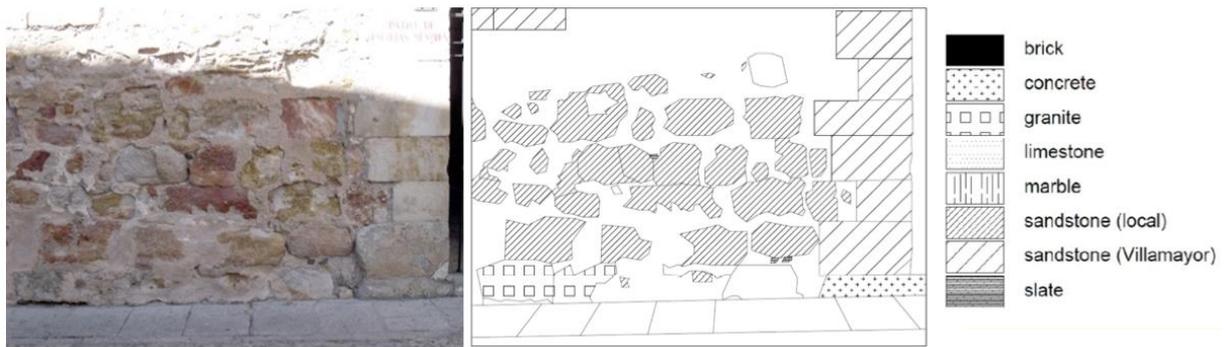
The external wall is mainly made by a different kind of materials (Fig.2): Arcosic sandstone (Fig. 3a) and by Piedra Sangrante (Fig. 3b); meanwhile, the arc is build by blocks of Villamayor Sandstone, a very fine-grained sandstone (Fig. 3c) [3], with a recent concrete base. Spread to the wall is also possible to find small pieces of Shale, Granite, Brick and Cement (Fig.2).

Fig. 2. External wall of Patio de Escuelas Menores: macroscopic petrographic characterization.

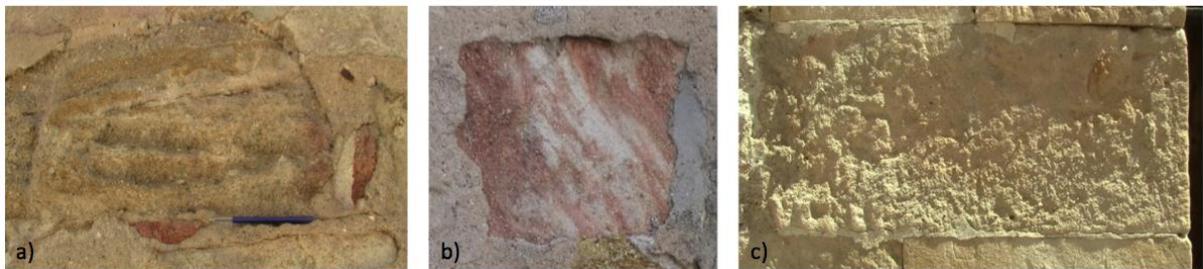
Fig. 3. Building's materials of external wall: a) Arcosic Sandstone (matrix with Quartz Clasts); b) Piedra Sangrante; c) Villamayor Sandstone.

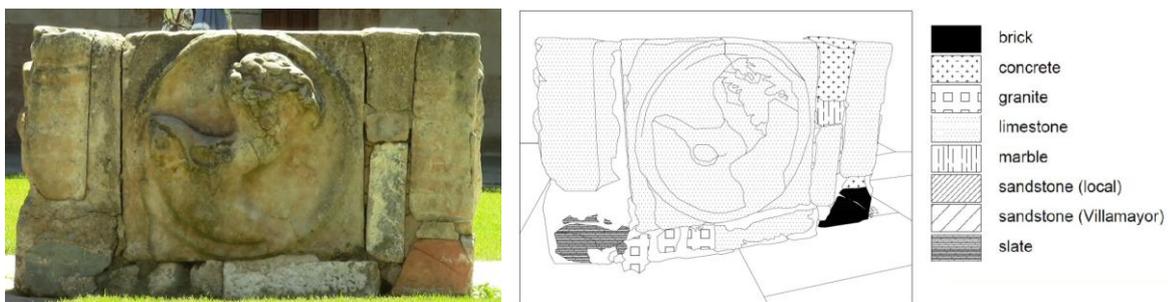
Fig. 9. The Northwest Wall of the fountain: map of material.

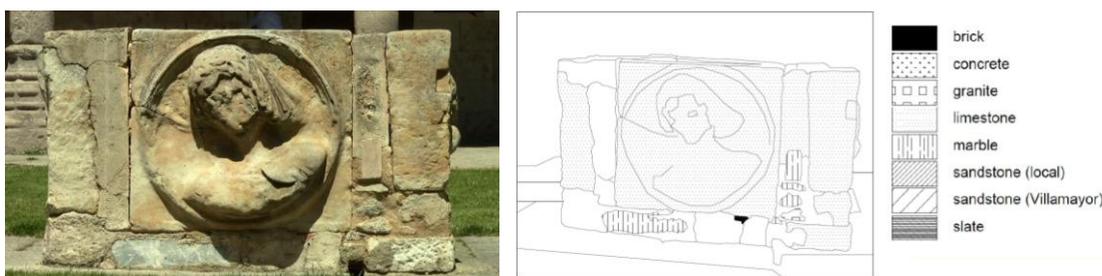
Fig. 10. The South-east Wall of the fountain:map of material.
